STRENGTHENING SikaWrap® FX

CARBON FIBER STRINGS FOR STRUCTURAL STRENGTHENING APPLICATIONS

SikaWrap® FX - MULTIPLE APPLICATION POSSIBILITIES

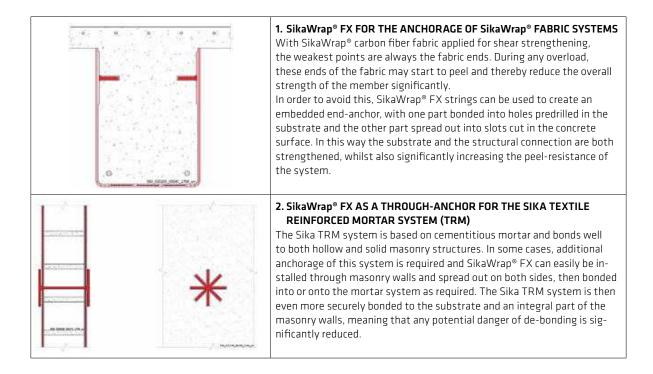
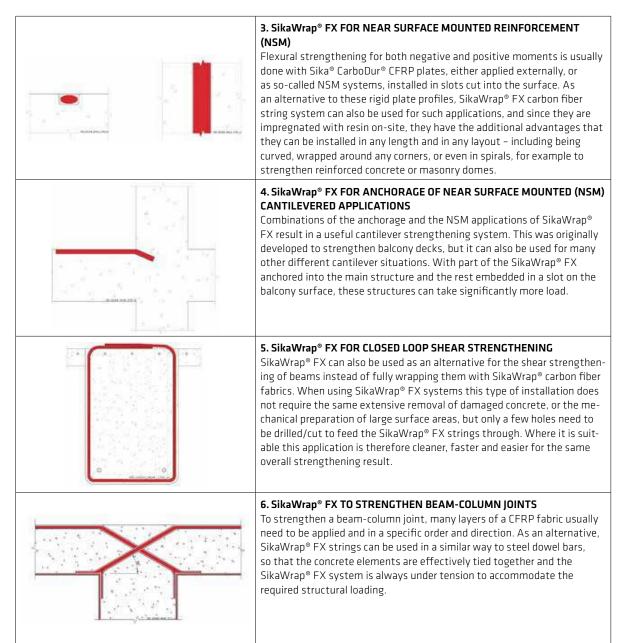
SikaWrap® FX products are dry carbon or glass fiber strings, encased in a plastic envelope to protect them from contamination and fraying. Additional numbers are used in the FX product names to indicate the weight of each in grams per linear meter and the letters C or G to denote that the fibers are carbon or glass. All of the SikaWrap® FX products are supplied to site in rolls and then cut as required for their many different applications and structural configurations.

SikaWrap® FX carbon fiber strings are impregnated on site with either Sikadur®-300 or Sikadur®-52 epoxy resins, before they are embedded into the prepared predrilled holes, slots cut into the substrate, or concrete surfaces, dependent on the type of application.

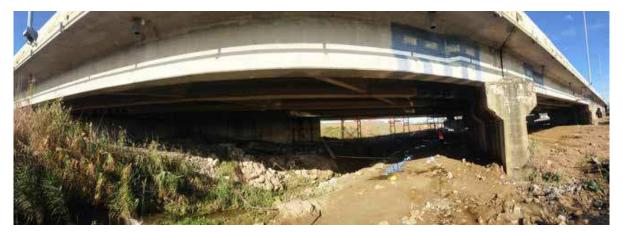
Structural retrofitting of the Krousovitis Bridge, Greece

THE OLD BRIDGE OF KROUSOVITIS CREEK in Northern Greece was built around 20 years ago and has four spans of approximately 120 m that each consist of four pre-stressed beams, which are connected by transverse girders to support the reinforced concrete deck slab.

The additional shear strength was achieved by external wrapping of the beams with SikaWrap® carbon fiber fabrics that were impregnated and bonded on site with Sikadur® epoxy adhesives. The geometry of the different cross-sections required additional anchorages for the SikaWrap® fabrics and these were provided using the SikaWrap® FX system.

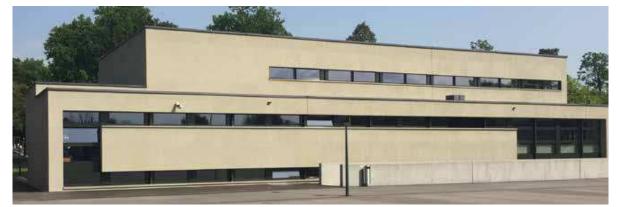
Extension of a Sports Hall, Biberstein, Switzerland

Using steel links or strengthening by completely wrapping the beam with a composite fabric strengthening system was not possible because the concrete floor slab is supported directly on the top of the beam. The engineers therefore selected to use the SikaWrap® FX system as the best alternative option, which consisted of the carbon fiber strings bonded directly onto the prepared sides and bottom of the beam, and through the core holes drilled at the top of the beam. Once the strings had hardened the holes were filled and sealed with Sika AnchorFix® epoxy resin. In this way the engineers were able to fulfill the same strengthening requirements as complete CFRP fabric wrapping, but with a system that was also practical to install.

PRACTICAL TO INSTALL COMBINATION OF SIKA SYSTEMS EFFICIENT STRUCTURAL STRENGTHENING Additional note: Before applying the SikaWrap® FX system for shear strengthening, the beam was also laterally strengthened using Sika® CarboDur® plates on each side, to ensure the required flexural strength and load bearing properties were maintained. The core drilling works for the end-anchorage of the shear strengthening loops was executed after these plates were installed and had cured sufficiently.

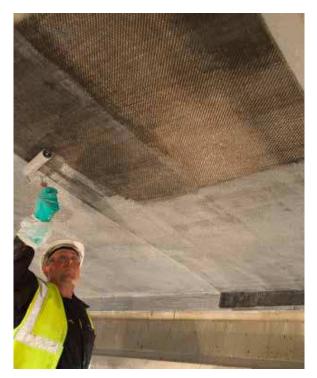
Merrion Centre MSCP, Leeds, UK

The initial condition survey and assessment found severe steel reinforcement corrosion in various areas, mainly due to winter de-icing salts penetrating into the concrete decks through cracks in the surface. Due to corrosion related damage and concerns for the structural integrity, substantial concrete repair and protection works were necessary. This included structural strengthening measures, including flexural strengthening of reinforced concrete beams with an increased bending moment.

The structural strengthening measures that were required included the flexural strengthening of the beams that had excess deflection, together with overall strengthening of the main parking deck slabs. These decks were also strengthened overall to ensure that despite any loss of section and corrosion damage over the years, the original design load capacity was correct and would be maintained for the future. A single layer of SikaWrap® bi-directional carbon fiber fabric was used to provide the additional moment capacity and meet reduced deflection requirements.

STRENGTHENING SikaWrap® FX During the carbon fiber design phase, the calculations showed a potential peeling issue with the fabric applied on the soffit of the slabs where they met the supporting beams. However this issue was solved by introducing SikaWrap® FX carbon fiber strings as anchors installed into holes predrilled into the beams at an angle of 30° above horizontal, with the SikaWrap® fabric reinforcement then applied and bonded over them. The parking structure refurbishment works were completed with the application of a new Sikafloor® waterproof deck coating system, designed to accommodate the future exposure to traffic and weathering, whilst preventing the future ingress of water and de-icing salts into the slabs. This complete integrated Sika systems approach also ensured minimal disruption for the owner, their tenants and their customers as many of the parking areas could still be used during much of the phased works.
