REFURBISHMENT STRUCTURAL STRENGTHENING WITH SIKA SYSTEMS

FOR OWNERS OF BUILDINGS AND CIVIL ENGINEERING STRUCTURES

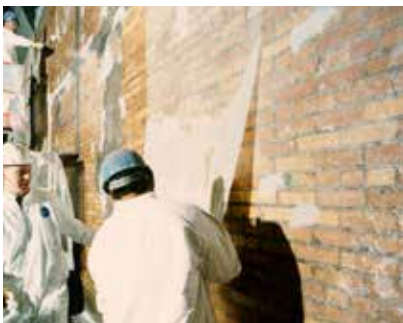
SEISMIC UPGRADING /EARTHQUAKE DAMAGE REPAIR

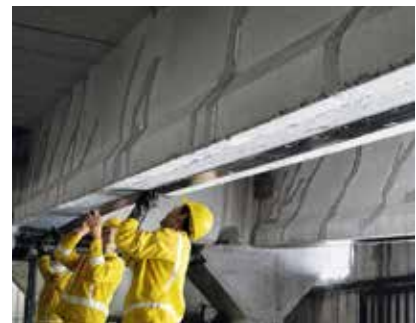
CRACK PREVENTION/REDUCTION

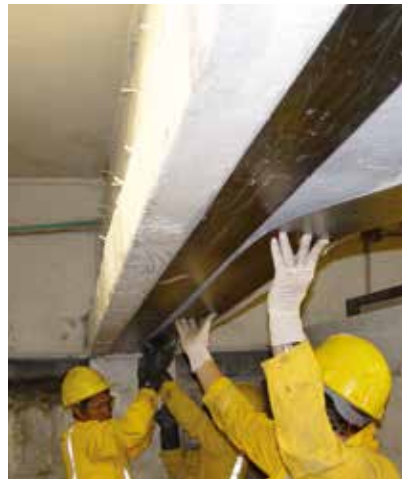
The Sika CarboDur® System

- Sika CarboDur®: CFRP plates and rods
- Sikadur®-30 and -30 LP: Structural epoxy resin adhesives
- Sika CarboHeater: Rapid curing and hardening equipment

The Sika CarboDur® System is the most widely recognized and established carbon-fiber-reinforced polymer (CFRP) strengthening solution available worldwide. It consists of Sika CarboDur® CFRP plates and rods, together with the structural epoxy resin based adhesives Sikadur®-30 and Sikadur®-30 LP. This simple, tested and well proven, highly durable system has outstanding performance. With the Sika CarboHeater curing times can be accelerated and down time minimized, even at lower temperatures.

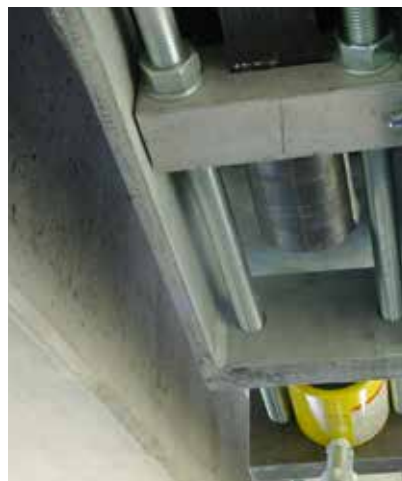
The Sika CarboStress® System

- Unique pre-stressed strengthening system
- Advantages of Sika CarboDur® CFRP plates
- Advantages of post tensioning
- StressHead anchorage system

Post-tensioning: a force is applied to create permanent stress in a structure, so that it can withstand load more efficiently or with less total deflection. In conventional post-tensioning, the load is put on steel tendons within the concrete structure, however with the Sika CarboStress® system, the advantages of the Sika CarboDur® CFRP plates and post-tensioning techniques are combined to form a unique active external strengthening solution.

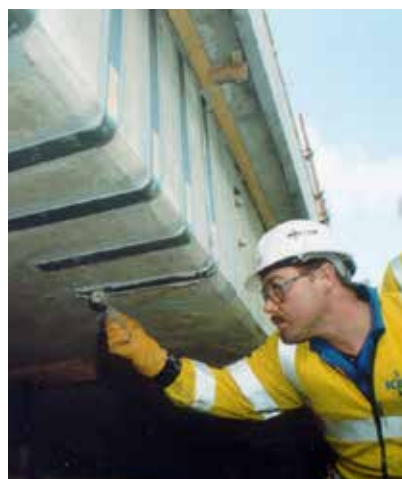
The Sika CarboShear System

- Unique L-shaped CFRP plates/brackets

The shear capacity of concrete beams can be increased by the external applied Sika CarboShear L-shaped profiles. Installation is fast and easy, excellent anchorage is assured and no drilling through the top slab is required.

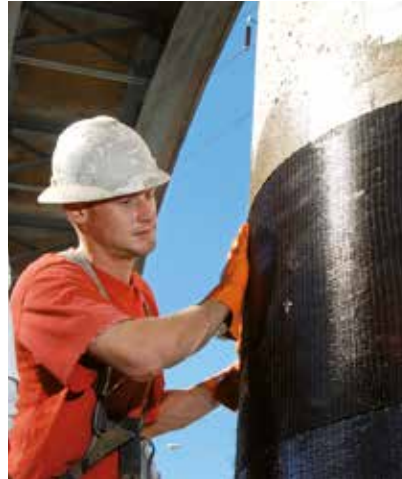
The SikaWrap® Fabric Strengthening System

- SikaWrap® Fabrics
- SikaWrap® FX fabric anchors
- Sikadur®-330 epoxy based 4in1 product (primer, filler, impregnating resin and adhesive)
- Sikadur®-300 epoxy based impregnation resin and adhesive
- Saturator Machine

The SikaWrap® fabric strengthening system consists of woven or stitched, unidirectional, carbon and glass fibre fabrics and Sikadur® impregnating resins. This system provides a wide range of solutions to meet different demands on many different types of projects. The installation is extremely flexible and accommodating of different surface planes and geometry, making this a very multi-functional material for many applications including confinement, shear, seismic upgrading and weak substrate strengthening.

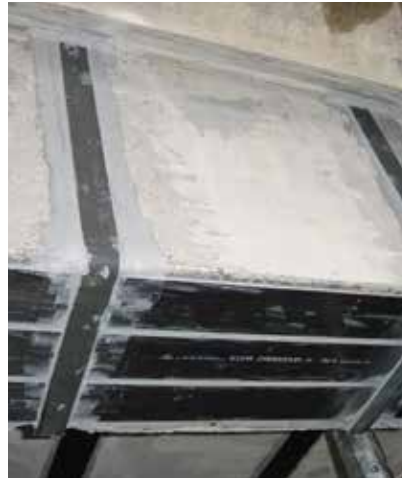
Using Combination of Sika Strengthening Systems

- Sika CarboDur®
- Sika CarboStress®
- Sika CarboShear
- SikaWrap®

The combination of all of the different Sika Strengthening Systems is possible and allows unique solutions to be engineered, especially for:

- Shear and flexural strengthening
- Enhanced end anchorages

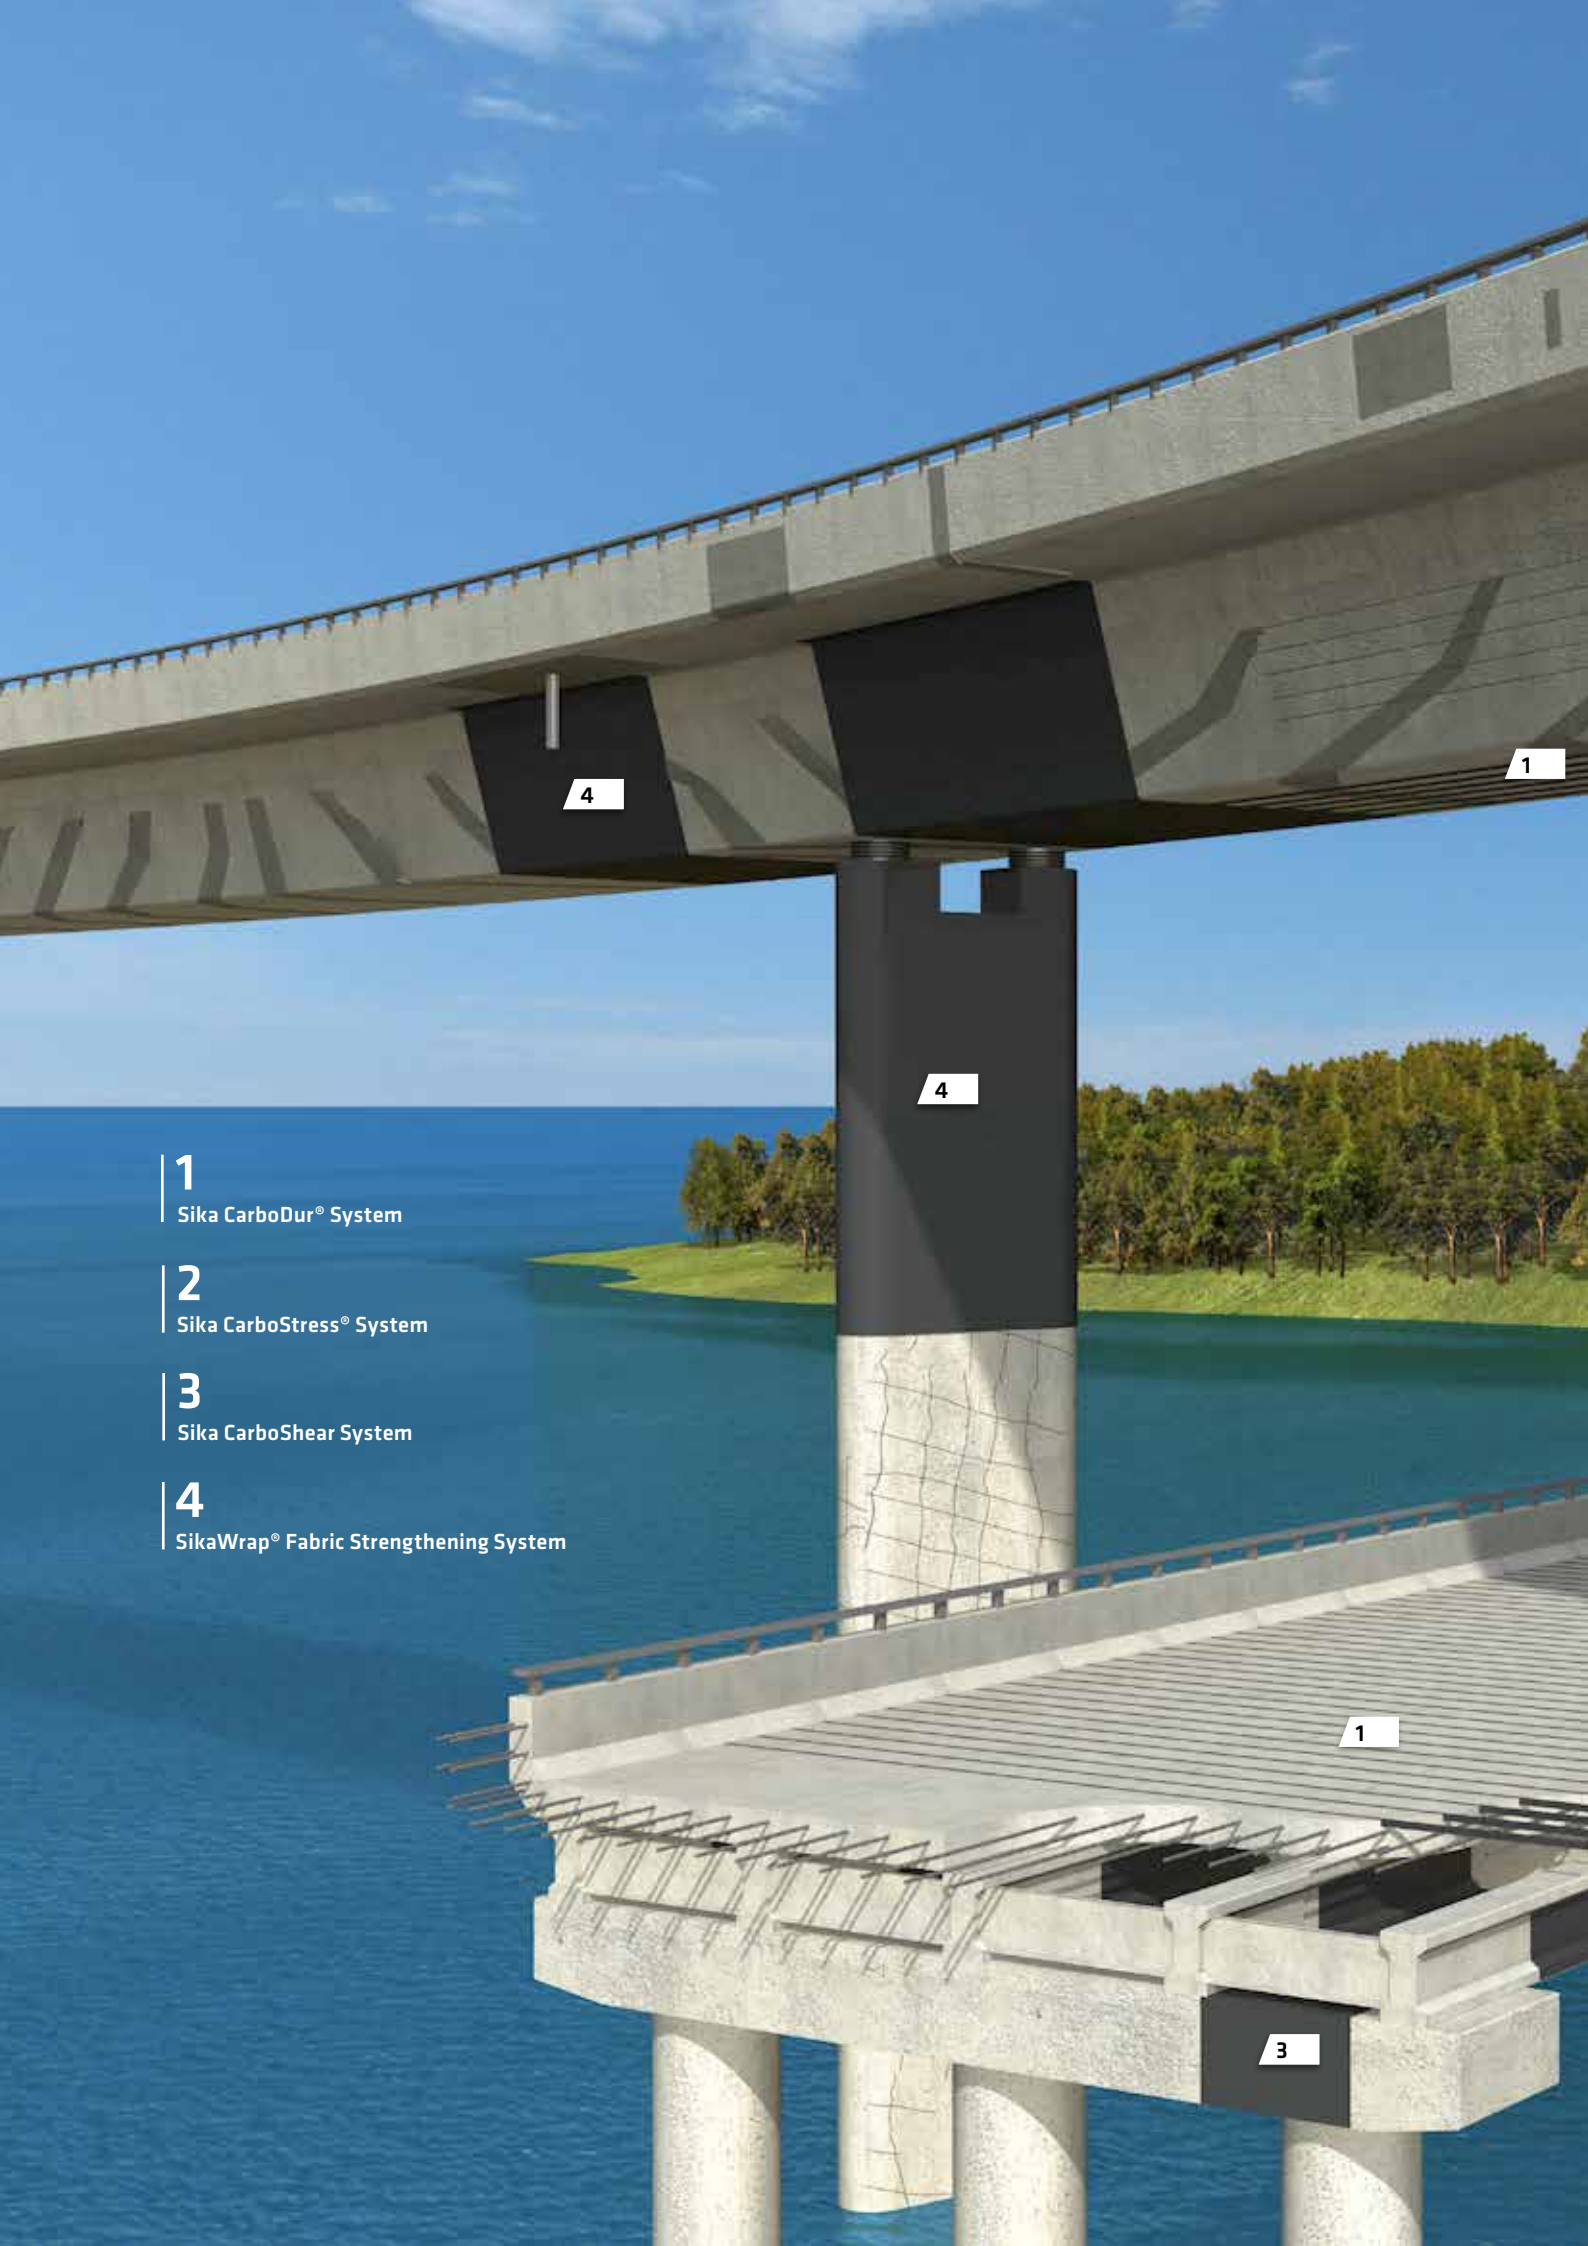
Sika CarboDur® System

Sika CarboStress® System

Sika CarboShear System

SikaWrap® Fabric Strengthening System

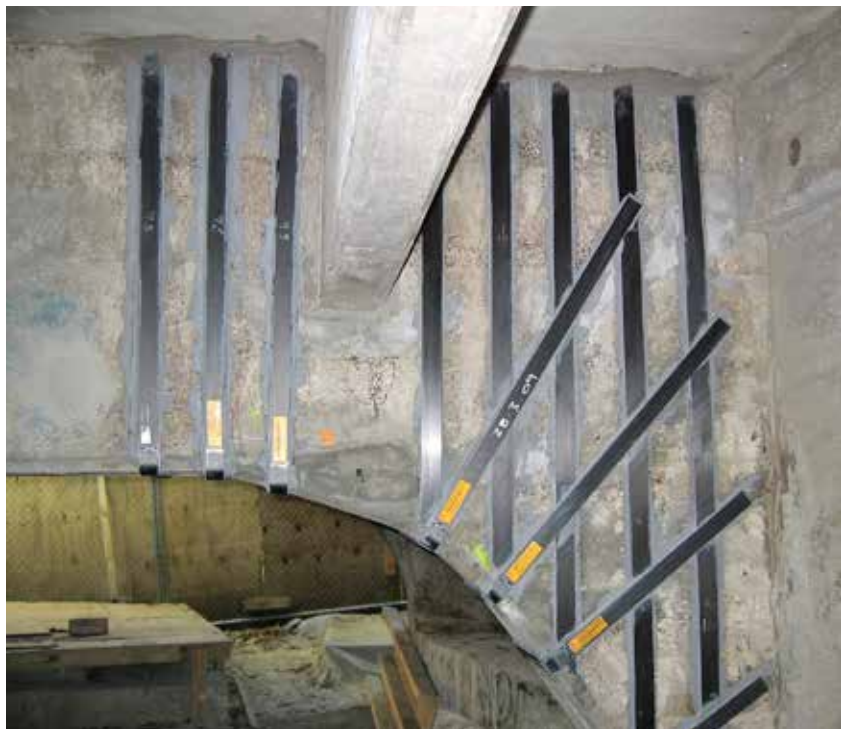
Sika CarboDur® strips and CarboShear L plates bonded to the concrete structure.

Sika CarboDur® CFRP plates were installed on the underside of the reinforced concrete beams to provide additional mid-span movement resistance. The Sika CarboShear L shaped CFRP profiles were then installed, in pairs, around the beams and up into the deck slab to improve the shear performance.

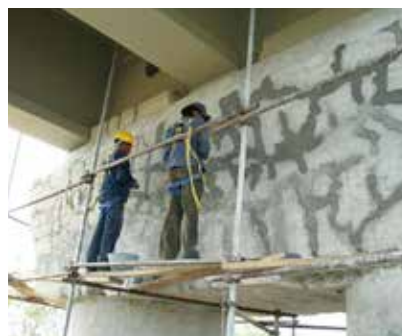
Repair

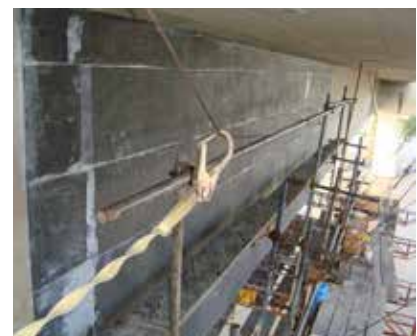
Strengthening with SikaWrap®

Few years after the initial concrete repair works were completed shear cracks were noticed in the beams and the requirement for structural strengthening was decided by the Engineers. After sealing and filling the cracks with Sikadur® injection resin, the substrate was prepared and a lightweight SikaWrap® fabric strengthening system was applied in two directions and finally the areas were covered with a SikaTop® coating.

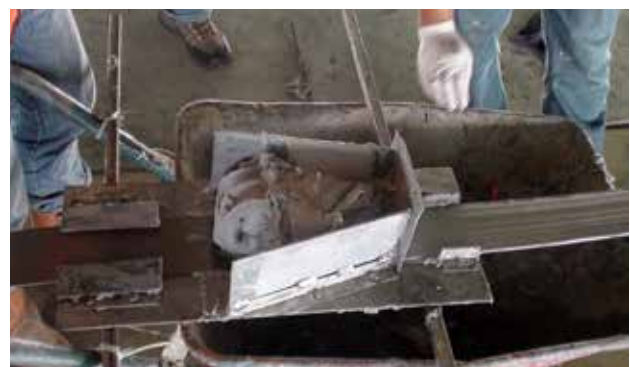
Coating of CarboDur® plates with Sikadur®

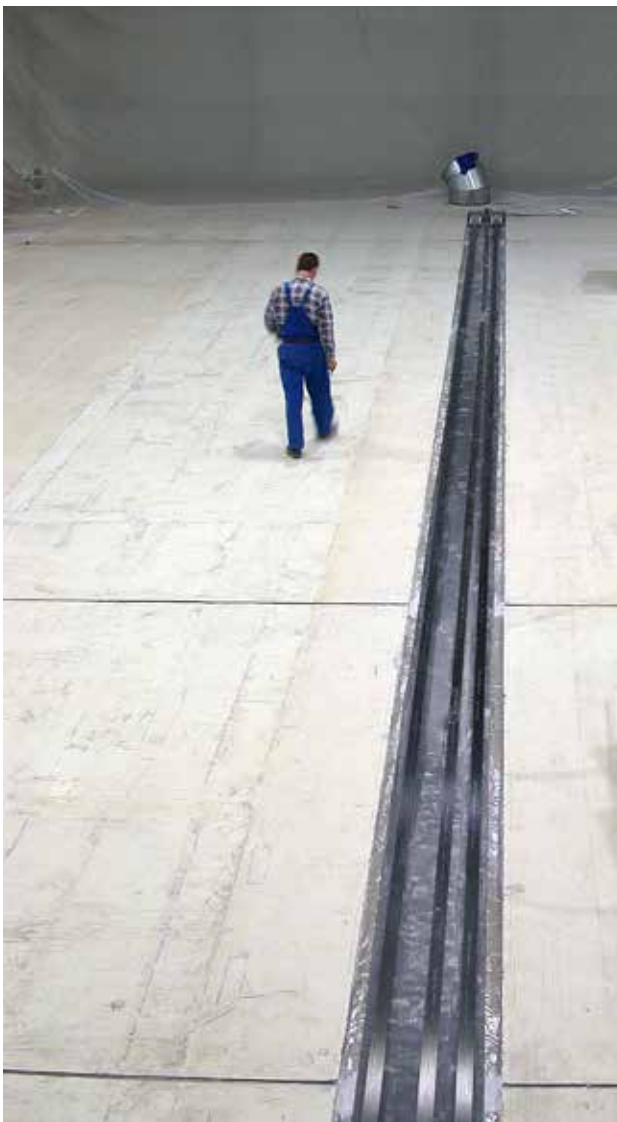
The longest post-tensioned CFRP-plates ever installed

With 29 m this is the one of the longest post-tensioned CFRP plates ever installed in the world.

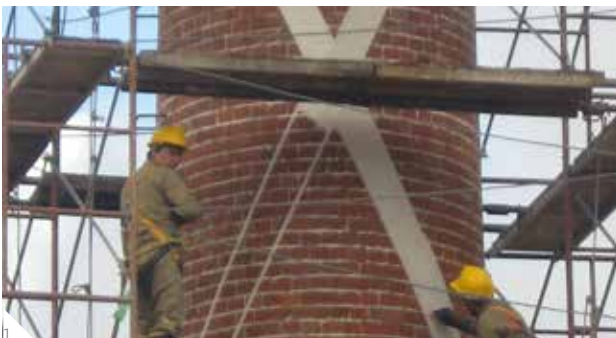
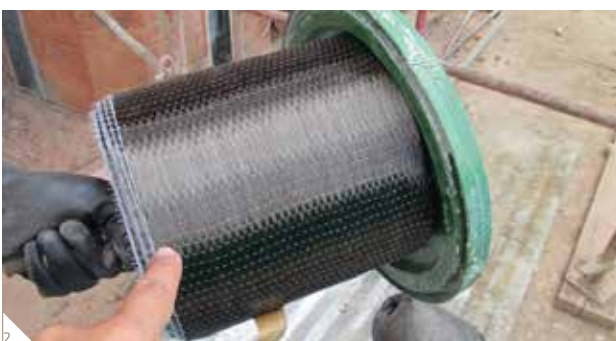
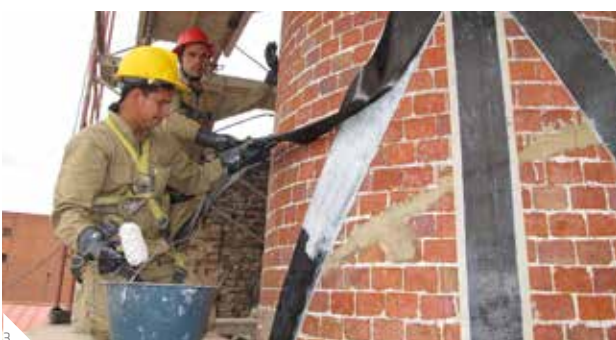
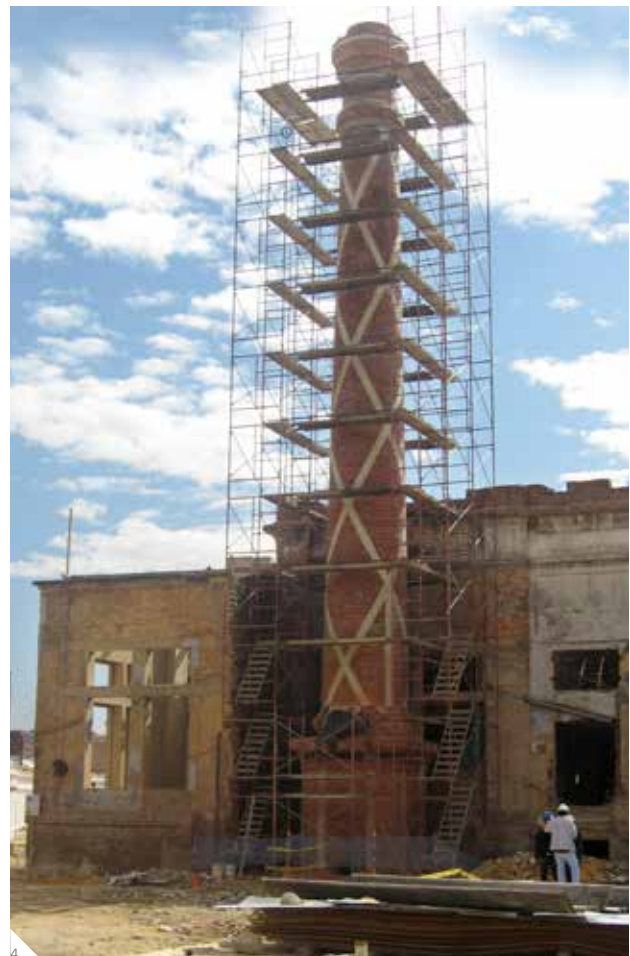
- 1 Substrate levelling
- 2 SikaWrap® roll
- 3 Installation of SikaWrap®
- 4 Coated strengthening system

A complete Sika solution was selected. After cleaning the structure thoroughly, Sikadur® epoxy mortar was applied to level the surfaces and prepare them for application of the SikaWrap® fabric strengthening system. SikaWrap® fabric strips were then cut to size and applied symmetrically, both diagonally and vertically, to improve the strength of the whole chimney structure with a uniform appearance. Finally the whole masonry chimney surfaces were overcoated with an acrylic protective coating.
