# REFURBISHMENT

## Sika MonoTop<sup>®</sup>-4400 MIC FOR MICROBIAL INDUCED CORROSION IN SEWERAGE SYSTEMS

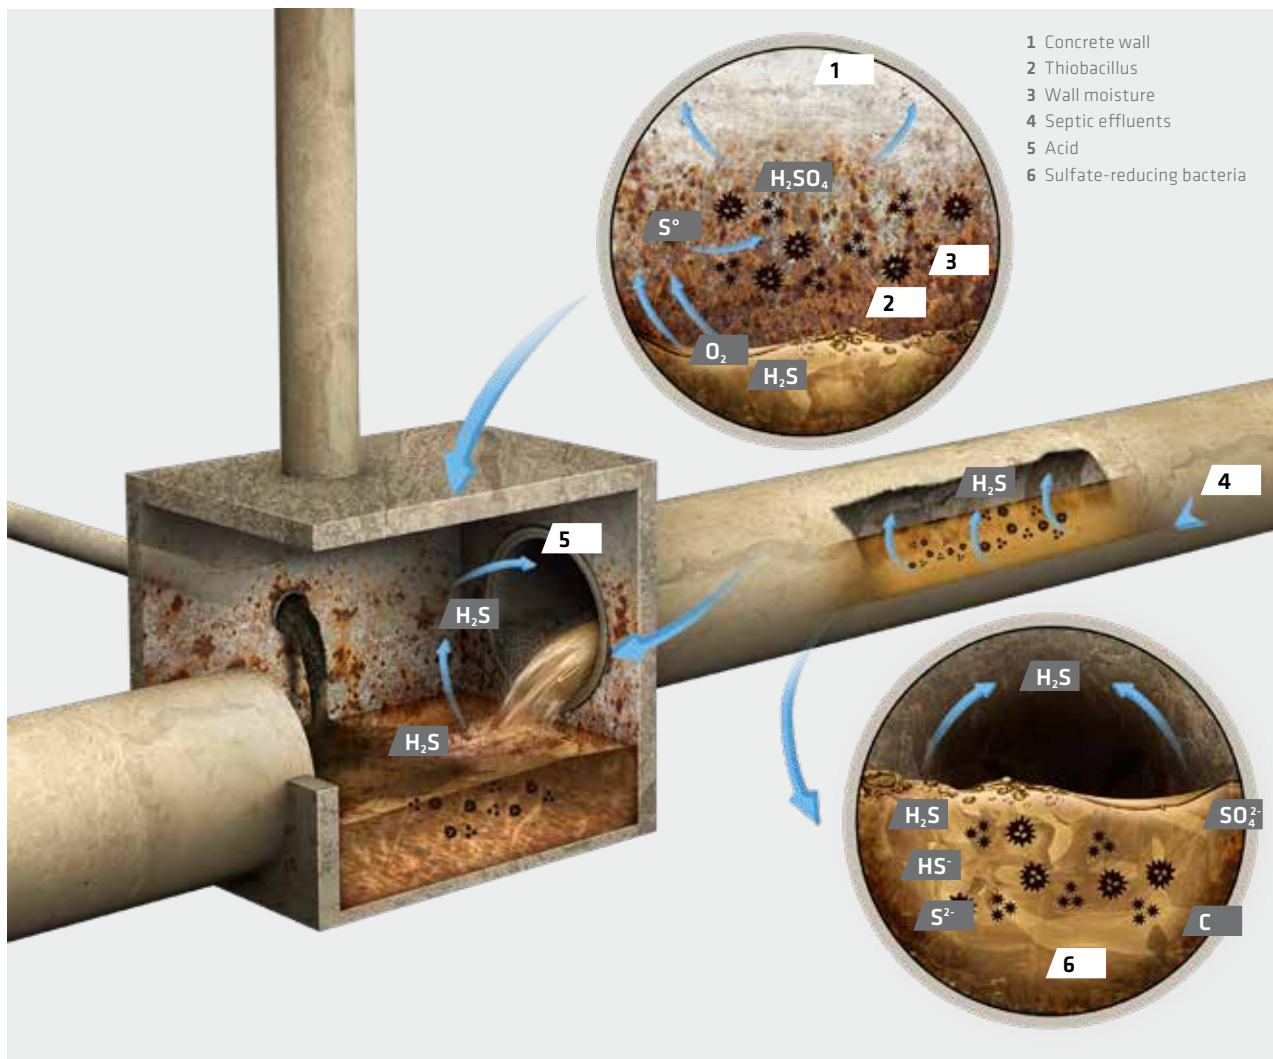
## MICROBIAL INDUCED CORROSION PRINCIPLES

Microbial induced corrosion happens when sulphates in biological waste are converted into sulphides through a biological process under the anaerobic

conditions below the waste-water line in the sewers. Above the waste-water line, the hydrogen sulphide gas that is released in this process forms aggressive and corrosive condensates with water such as sulphurous and then sulphuric acid.

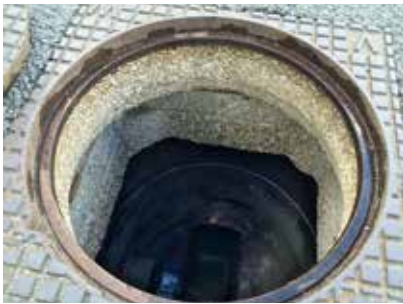
Manhole sewer entry after only 3 years in service exposed to biogenic corrosion.

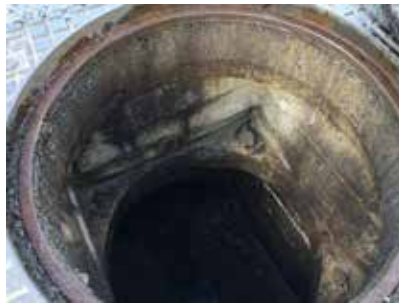
Manhole entry to storm water network after 3 years of service showing no deterioration.

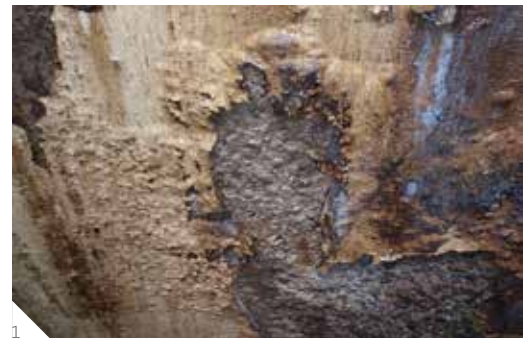
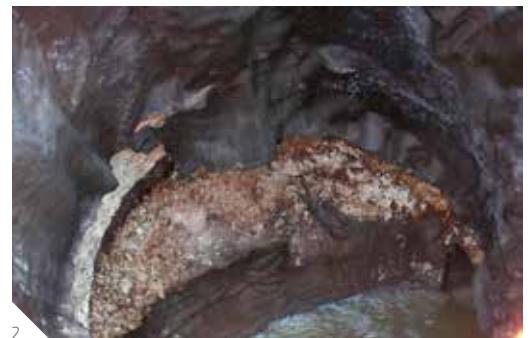
- 1 Example of polymer lining failures under H<sub>2</sub>S microbial induced corrosion conditions.
- 2 Example of polymer lining having failed to protect a mould from H<sub>2</sub>S corrosion.

In the past, epoxy resin coatings were used to provide some degree of additional protection against chemical attack including microbial induced corrosion, but in many situations this solution has also failed due to the extremely onerous application conditions in this environment. Many years of experience have now shown that in many situations the only reliable solution is to provide the necessary additional protection to the concrete surfaces with specially designed calcium aluminate cement based mortars.
