REFURBISHMENT PROTECTIVE COATINGS FOR CONCRETE

BUILDING TRUST

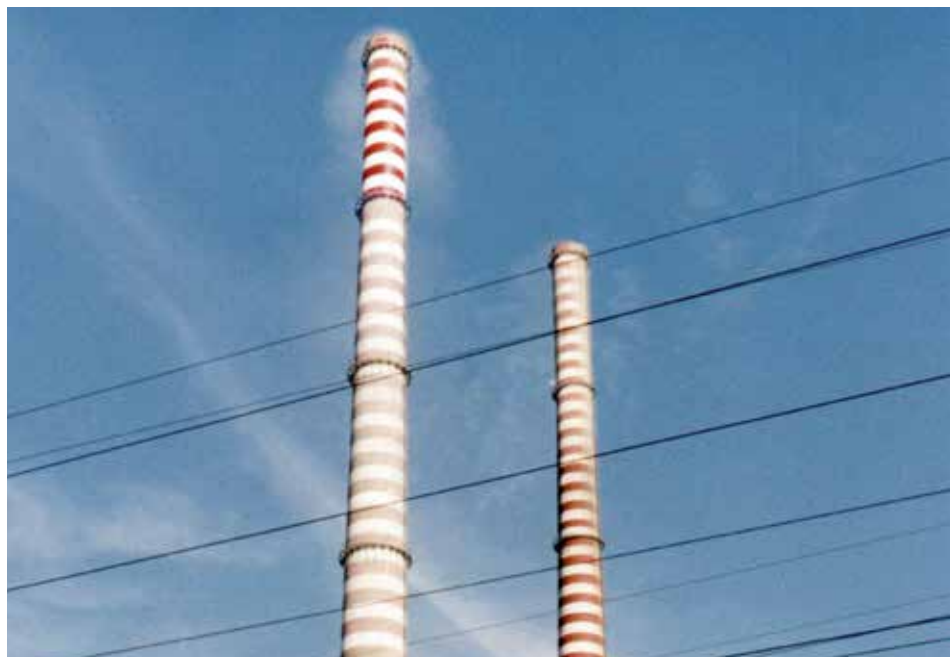
Chimneys in direct sunlight indicating variations in thermal exposure which are further exacerbated by the effects of the downward flow of hot exhaust gases during periods of temperature inversions.

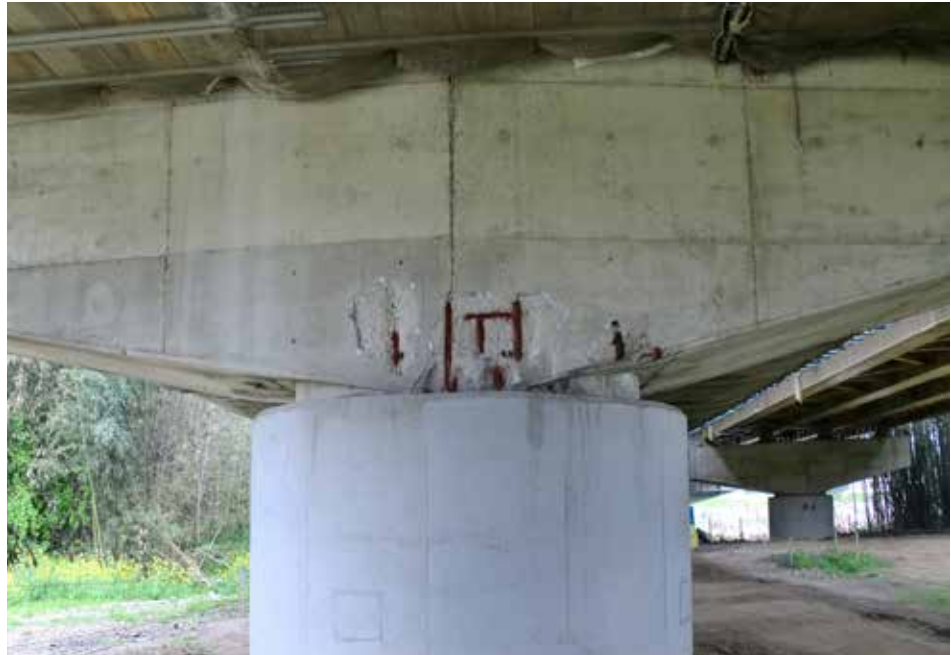
General corrosion induced by carbonation aggravated with low concrete cover issue.

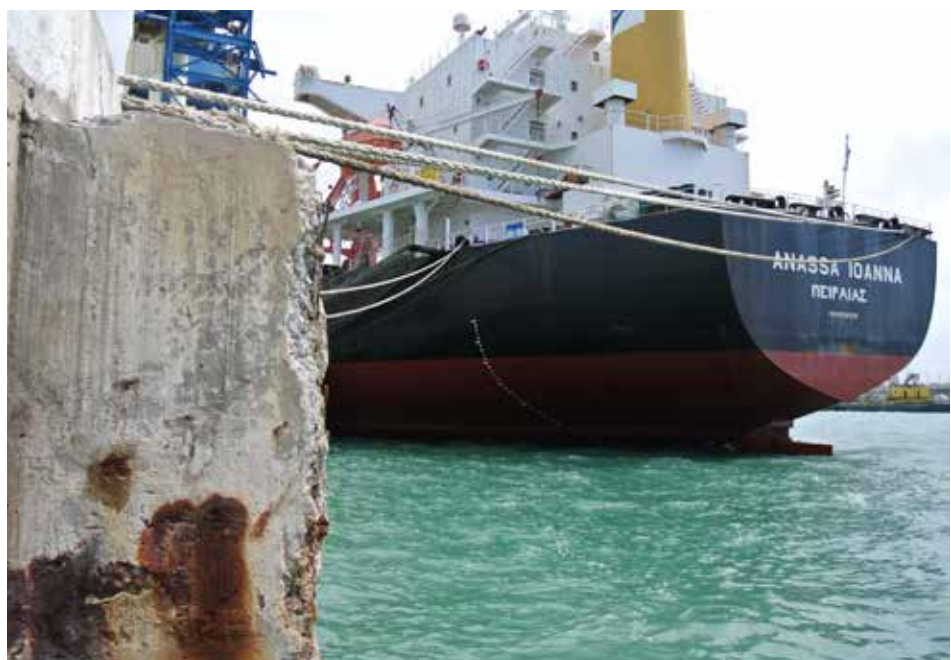
Reinforcing steel corrosion in a pier.

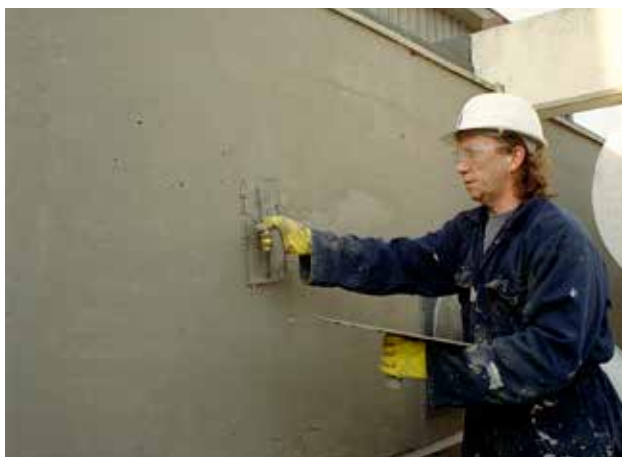
Sika MonoTop®-723 N: resurfacing mortar for hand and spray application.

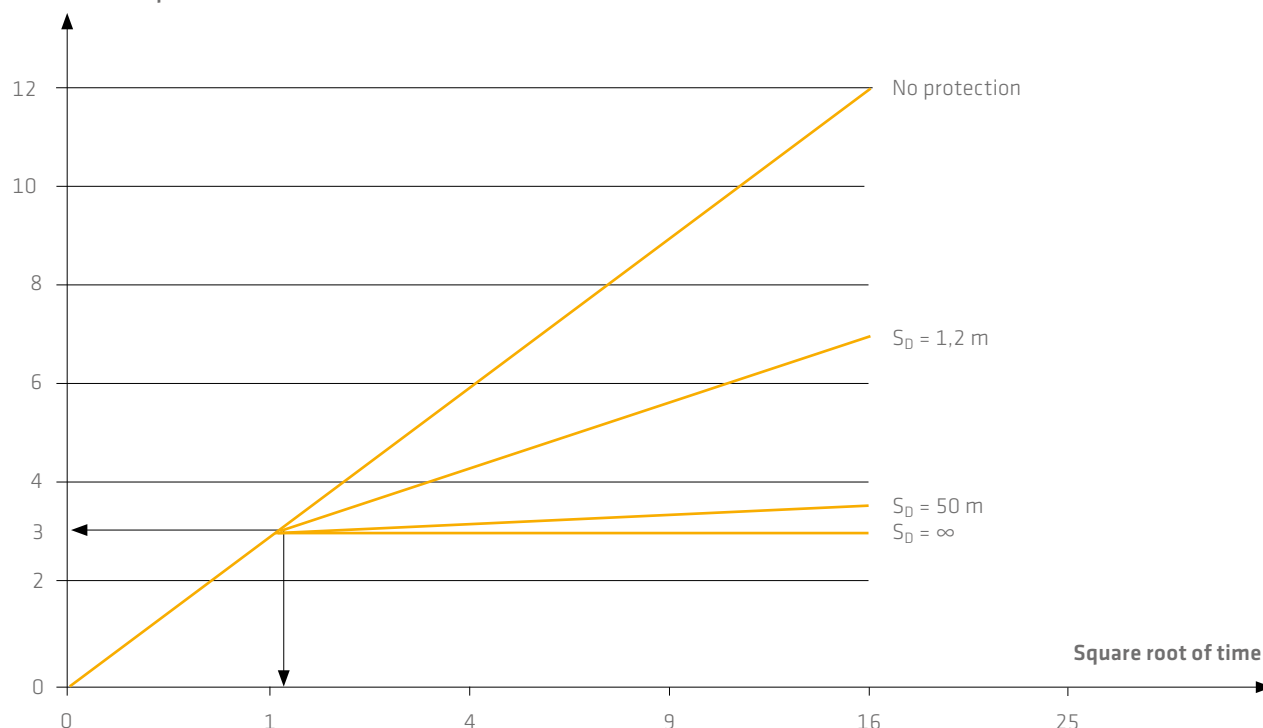
Carbonation depth in mm

Evolution of carbonation depth over time when different coatings are being used:

- No protection
- A basic decorative paint with no protection performance (SD = 1.2 m)
- A protective coating complying with the threshold of EN 1504-2 (SD = 50 m) and
- A complete stop of the carbonation progression (equivalent to an SD which has an infinite value).

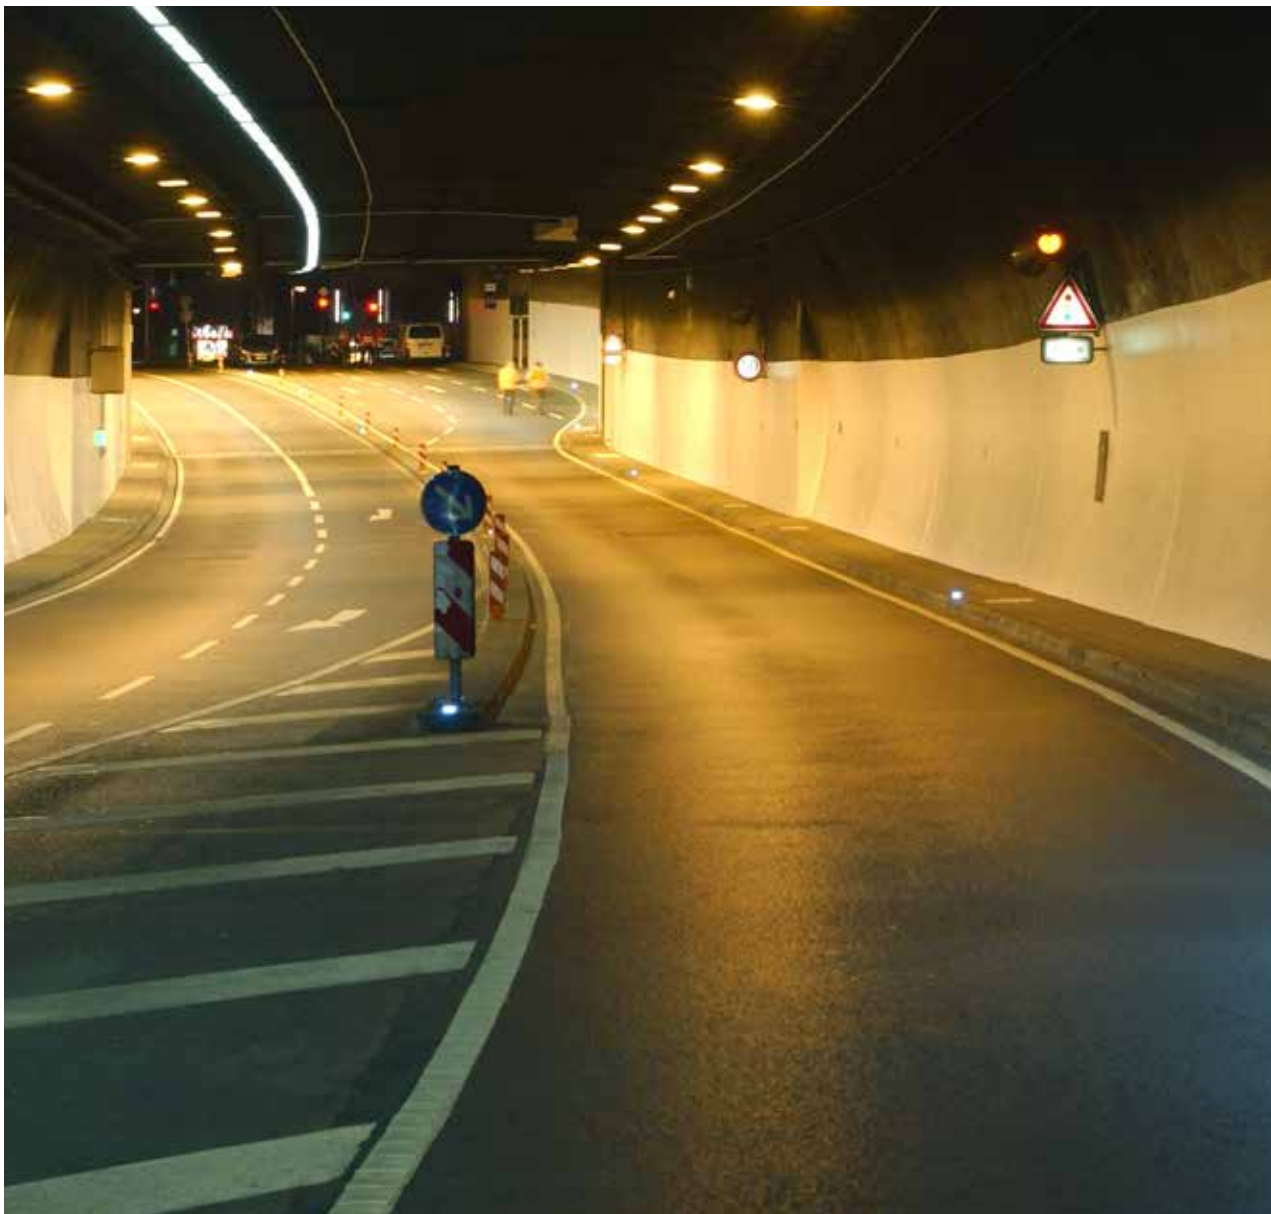
TUNNELS

Protective coatings in tunnels need to withstand the harsh environment (deicing salts, SO_x and NO_x pollution, plus abrasive cleaning procedures, etc.). Additionally they can be used in colours to improve the lighting and visual aspects and to prevent dust pick-up on the walls.

- Water borne epoxy Sikagard® WallCoat T
- or
- Water borne polyurethane Sikagard®-260 WPU

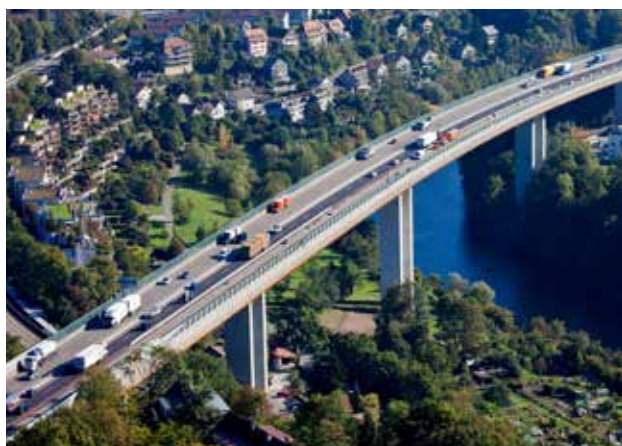
VIADUCT BRIDGE BERN, SWITZERLAND

A full refurbishment of the tangential A1 highway North of the City of Berne took place in the early 2010's including the Felsenau Viaduct (1.1 km long and up to 60 m high).

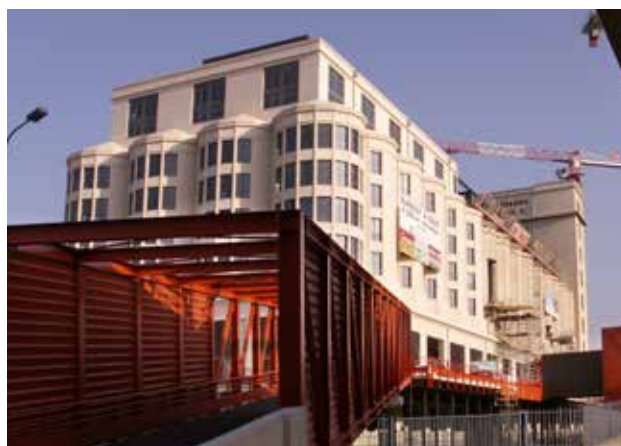
ARENCE SILOS MARSEILLE, FRANCE

The Arence silos were originally erected in the late 1920's and they have become a well-known landmark in Marseille. However the grain silos were out of use for many years and concrete was showing severe decays.

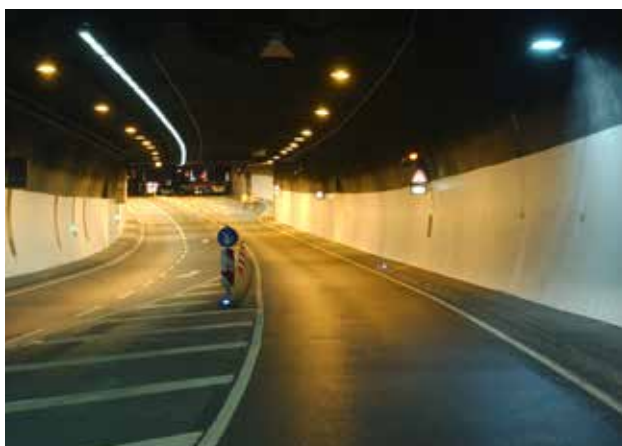
HESLACH TUNNEL, GERMANY

Stuttgart's Heslach Tunnel is the longest urban bi-directional tunnel in Germany. Around 50,000 vehicles use the centrally sited tunnel on a daily basis. The tunnel was built in the 1980's.

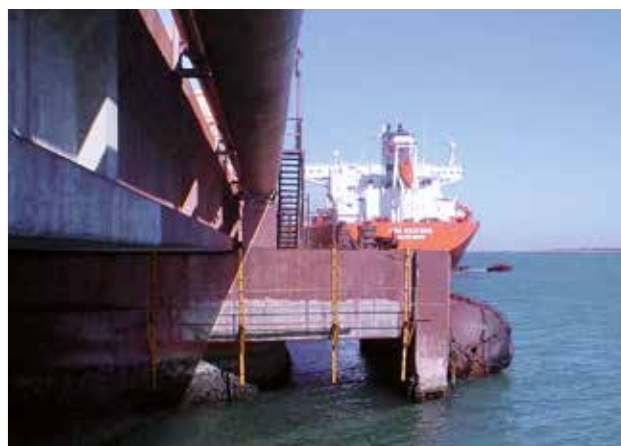
SALDAHAN JETTY, SOUTH AFRICA

Refurbishment of a 40-years old industrial jetty in Saldahan, South Africa. The jetty is used by the National Port to receive iron ore ships and by Petro SA for crude oil tankers. Despite remedial works carried out 15 years ago using system comprising of 8 to 9 coats of elastomeric coating, the jetty was already in need of repair.
